# REGULATORY REFORM (FIRE SAFETY) ORDER 2005

## Fire Risk Assessment

**Assessed Area:** Stanton House > Stanton House

**Date of Inspection:** 21 Dec 2023

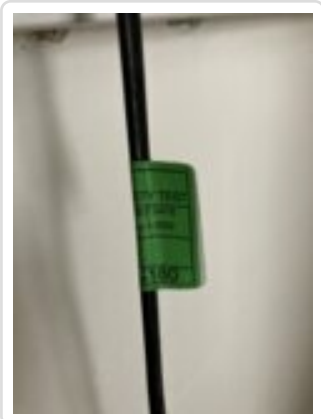
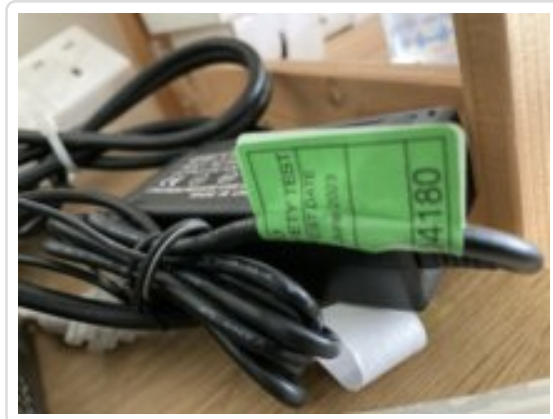
IMG\_3866

One item in office missed PAT - this will be picked up on next round of testing.

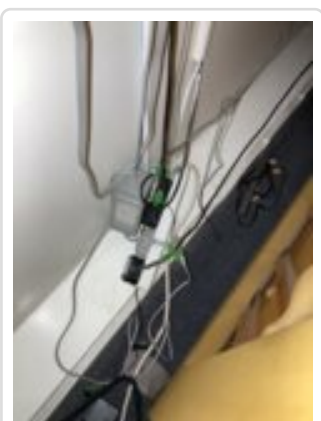
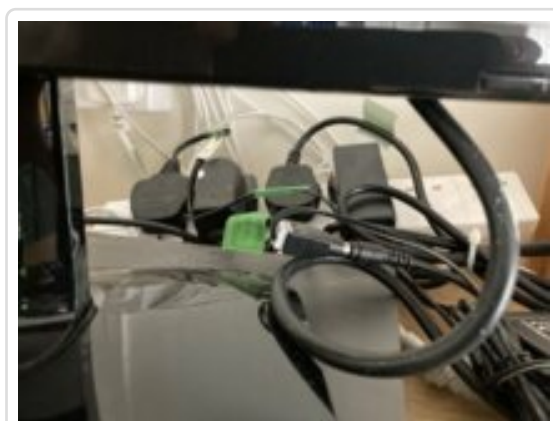
IMG\_3887

Cables at rear of piano stretched - Maintenance Officer made aware to reposition.

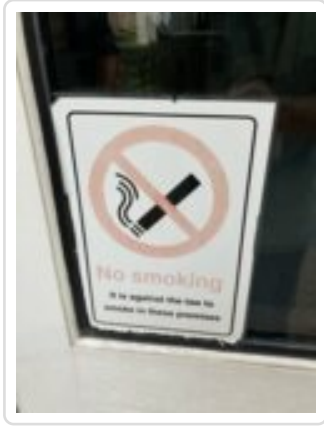
IMG\_3870

No smoking policy in place and signage displayed at building entrances.

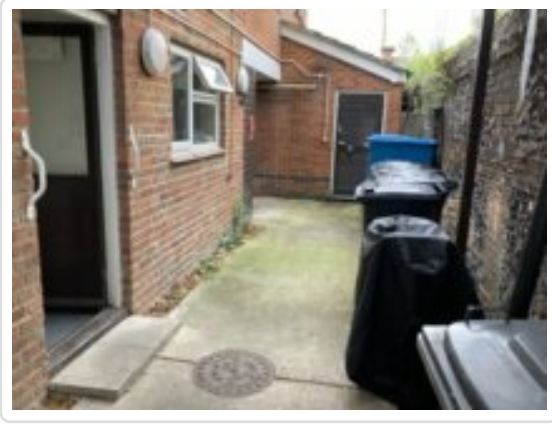
IMG\_3873

Area outside of boiler room clear of stored items.

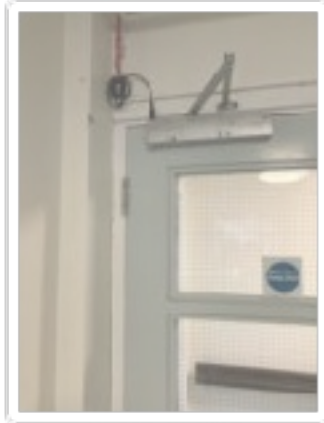
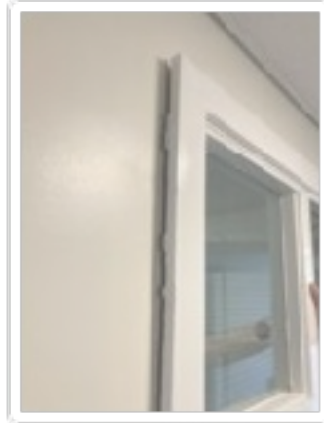
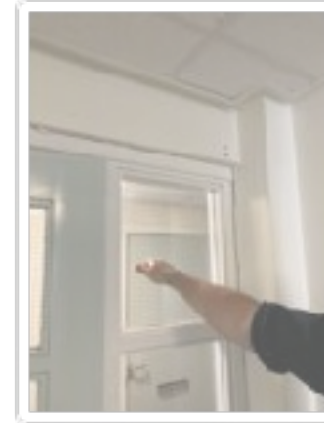
✔ Fire door set and screen loose in opening

Door SHFD007 on the ground floor has loose fixings and was visibly moving in the opening. The Maintenance Officer is aware and has reported for repair/replacement.

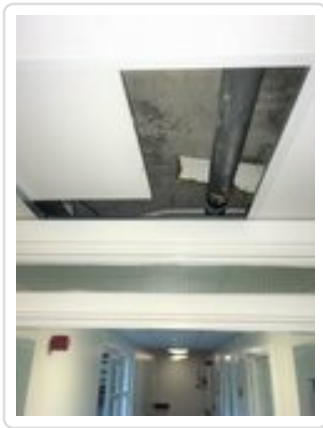
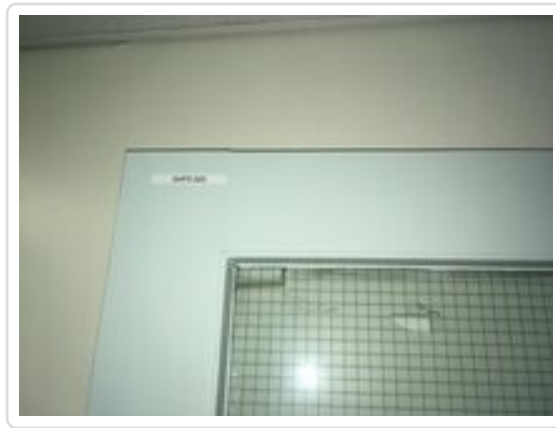
IMG\_7074

□ Compartmentation-ceiling void above cross corridor doors standard deficient

It is recommended that the voids above the false ceiling where there are cross corridor doors are surveyed to ensure there is adequate fire resistance up to the underside of the first floor slab.

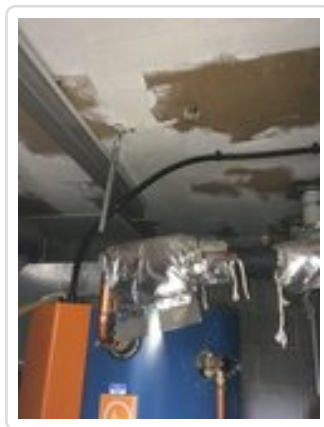
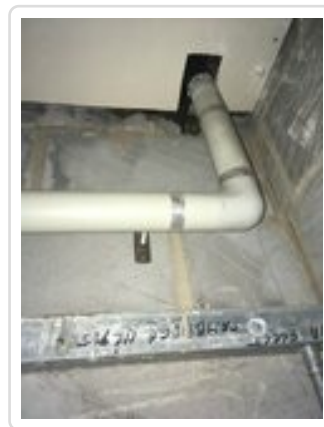
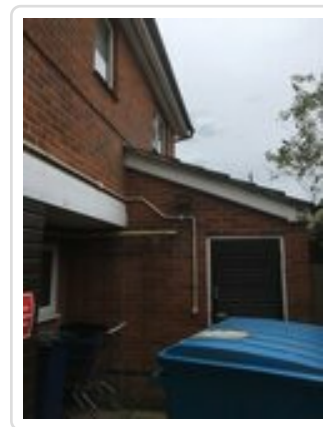
Flats are believed to be 60-minute compartments. All cupboards and risers are enclosed in 30 minutes fire resistance, as are hazard spaces such as the kitchen and lounge. However, a report by Ventro in October 2022 identified significant deficiencies throughout the building.
