Appendix 2

Photographs from residents showing existing changes to Accordia

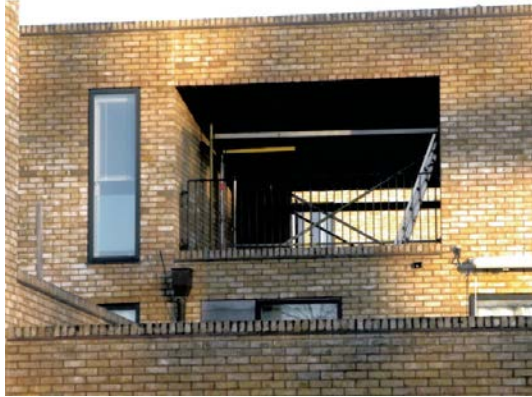
001

- 001-004 voids being in filled to create internal rooms
- 008-009 contrasting timber treatments
- 010-011,013 replacement of copper down pipes with plastic
- 014-015 screen of balconies
