# ABBAY HOUSE, CAMBRIDGE

## Report on its Significance and Future

January 2002

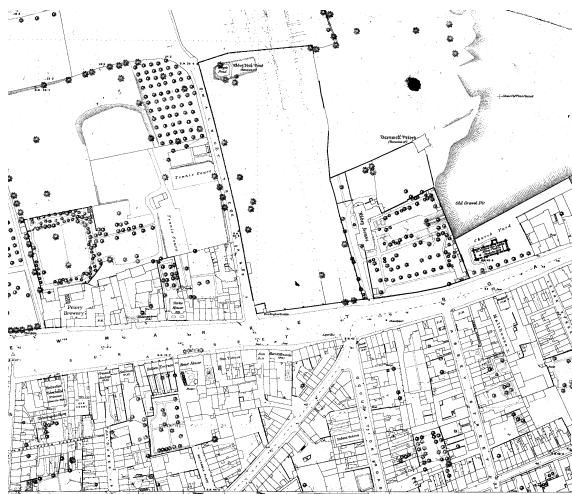
*Ordnance Survey 1886*

The vast majority of the houses survive and the area was a General Improvement Area in the 1970s. Although at one time consideration had been given to routing Elizabeth Way along Abbey Road, fortunately sense prevailed and the current route instead was chosen, which itself wiped out Walnut Tree Avenue, part of the original Abbey estate. Elizabeth Way with its commanding new bridge opened in 1971. Despite some settlement of the houses constructed on filled land, and recent flooding (to be addressed by alleviation works by the Environment Agency in 2002), the area is now a desirable place to live.

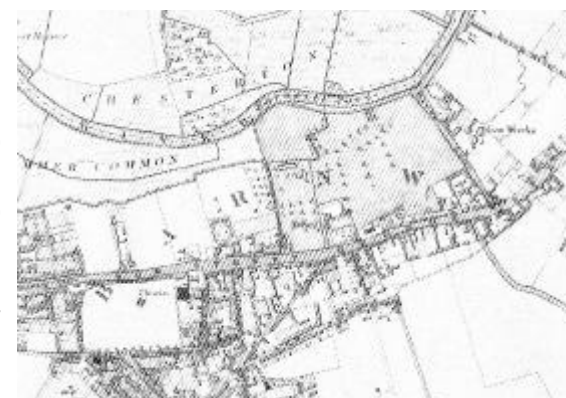
Baker 1830

It appears from the C19 maps that elements of the priory survived until the major development of the area after 1886. These included a fish pond to the NW of the house off Walnut Tree Avenue (roughly the line of Elizabeth Way today), various walls and a 'ruin' behind the Newmarket Road frontage roughly equidistant between the church and River Lane.

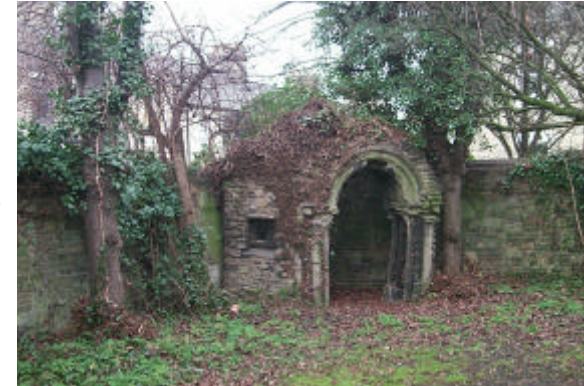
*Outbuilding, west garden*

### i) west garden

entrance created after south garden sold in 1886 though gates, piers and walls of reused material (some from priory). Garden contains (presumably C19) structures made from elements of priory fabric which need repair. Trees of particular townscape significance. Much of plot gravelled and used for vehicle parking.

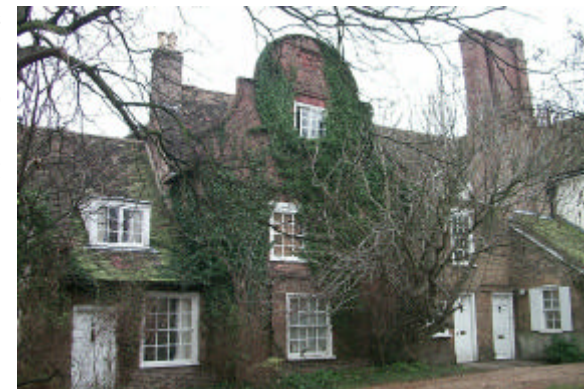
*West elevation*

### iii) west elevation

VERY HIGH

extremely important elevation which shows the various alterations and evolution of the building. The shaped gable and C16 chimneystacks are especially powerful and important. The staircase wing has been modified as recently as second half of the C20 and various alterations have been made to the window positions and addition of doors. Some minor alterations may be possible to windows and doors but should be very carefully considered and justified.

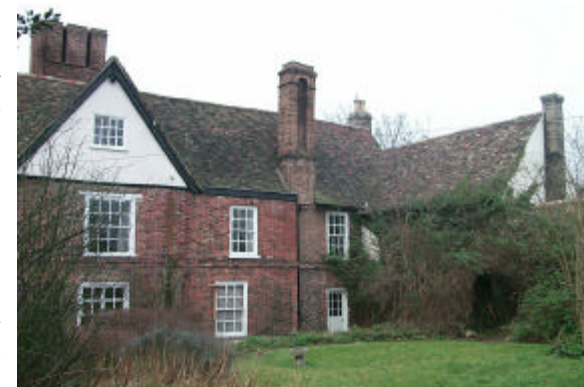
*East elevation*

### iv) east elevation

VERY HIGH

very important elevation although less of the original house is visible. Shows the evolution of the building over 500 years though again window and door positions and joinery is mostly C18 onwards. The variation of roof heights, gables, chimneys etc are especially important.

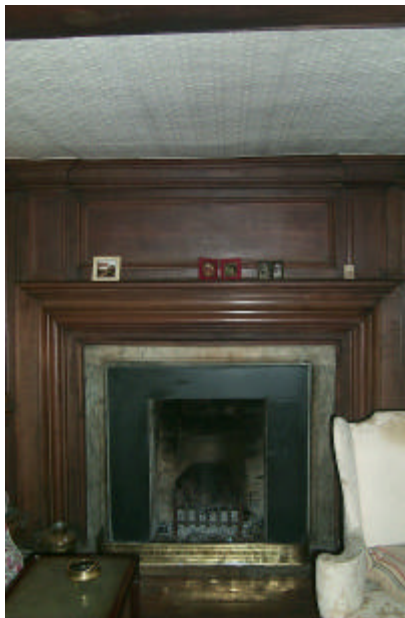
*Room 1, ground floor*

#### **i) Room 1**

significance: VERY HIGH

notes: very fine room with stained oak bolelection moulded panelling of c1700, contemporary door, fire surround and original longitudinal ceiling beam. C19 bay window inserted in west wall and panelling modified around it. Trap door access to basement in stained boarded floor.

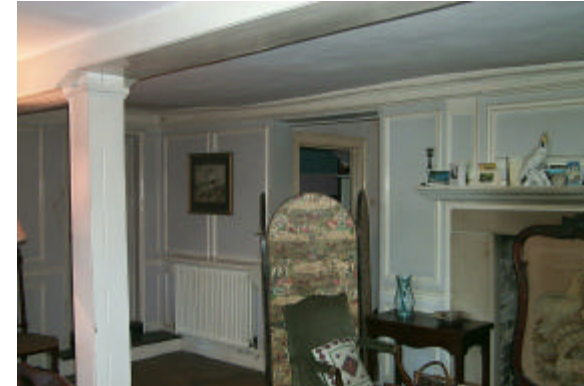
*Room 2, ground floor*

## ii) Room 2

VERY HIGH

very fine room with original longitudinal ceiling beam and painted bolelection moulded panelling of c1700 with contemporary doors, dado and cornice and fire surround. Floor of flags said to be reclaimed from the priory and laid on diagonal grid in 1812. Nice C18 corner cupboard. Window and external door probably C18 or C19 insertions which involved some alteration to the panelling. Boarded post supports beam at 2/3 span.

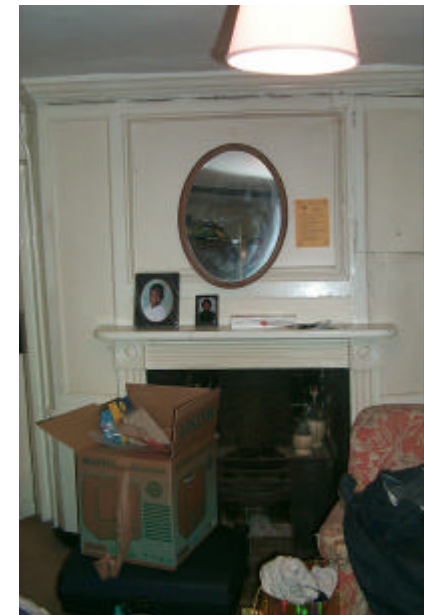
*Unit 2 study (room 7), ground floor*

## vii) unit 2 study (room 7)

HIGH

Original longitudinal ceiling beam, and C18 wainscotting. Corner fire with C18 surround and bookshelves and cupboards.

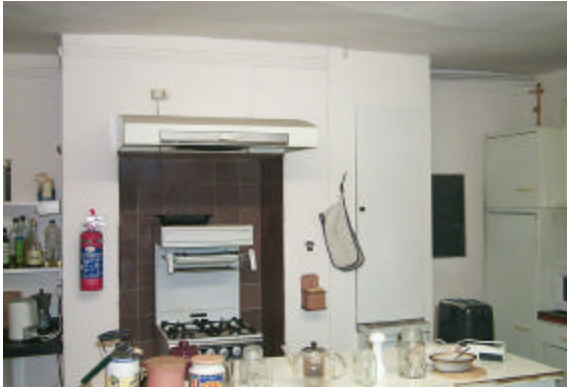
Unit 2 kitchen (room 8), ground floor

**viii) unit 2 kitchen (room 8)**

significance: SIGNIFICANT

notes: Original cross beam. Clad probably c1800. Picture rail otherwise all fittings etc modern, though earlier (probably c1800) fabric may be hidden.

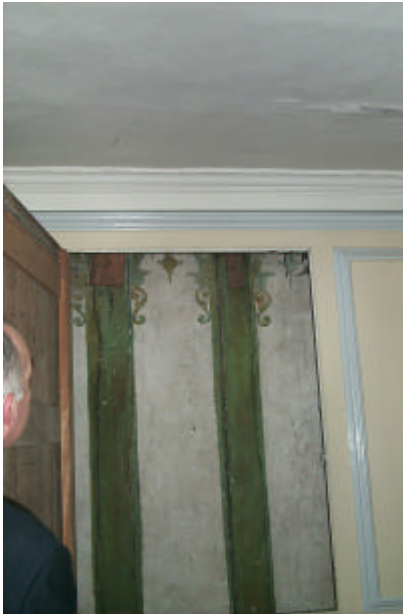
Unit 1 bedroom (room 14), first floor

**xiv) unit 1 bedroom (room 14)**

significance: VERY HIGH

notes: fine room with C17 panelling, altered around window. Panel opens to reveal original strapwork and jewel decoration to posts and infill on dressing room wall. This is thought to survive under other panelling.

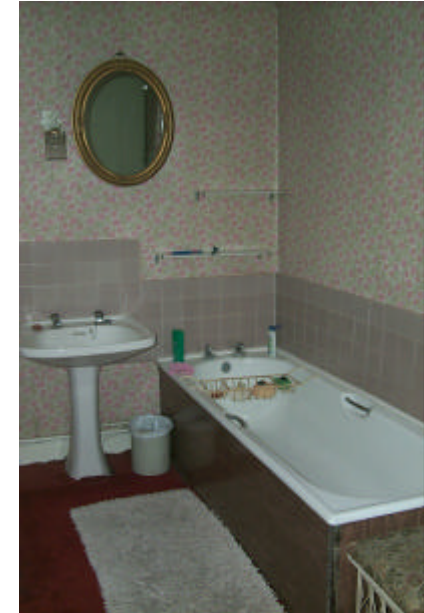
*Unit 1 bathroom (room 17), first floor*

**xvii) unit 1 bathroom (room 17)**

significance: SIGNIFICANT

notes: formed in the 1678 building.

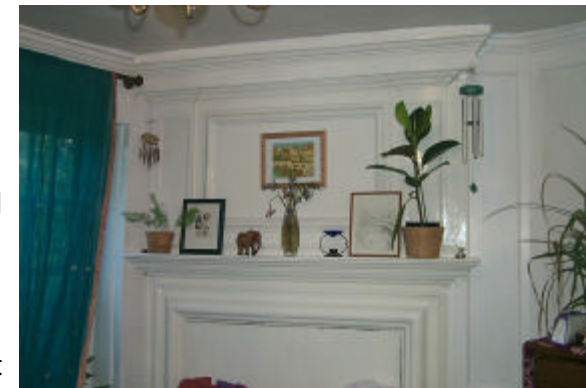
*Unit 2 bedroom (room 19), first floor*

**xix) unit 2 bedroom (room 19)**

significance: HIGH

notes: C18 panelling and fireplace with c1700 overmantel.

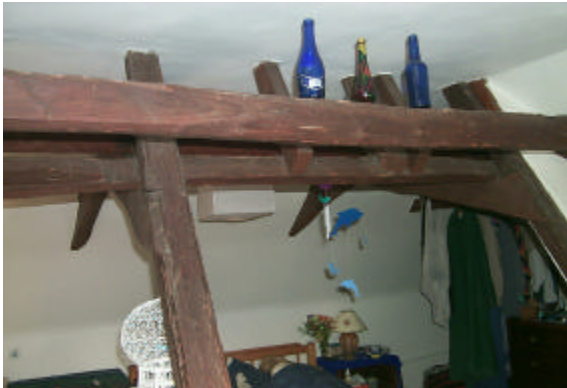
*Unit 2 attic bedroom (room 28), second floor*

### xxviii) unit 2 attic bedroom (room 28)

significance: HIGH

notes: late C17 roof structure with pine rafters and purlins and ash or elm collars. Precipitous staircase into the room.

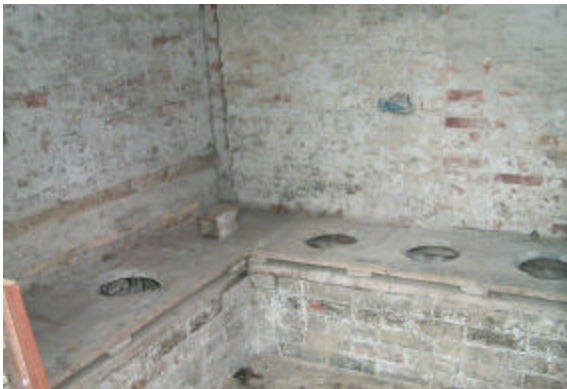
*Outside toilet (room 30)*

### xxx) outside toilet (room 30)

significance: HIGH

notes: includes remarkable 5-hole WC with rudimentary flushing system.
